Manhole Inspection Summary

Manhole # **S15SS_016MH**

Insp Date: **11/12/08 11:58 AM**

Location Address: **2523 LIBERTY HEIGHTS AVE** Cross Street: **BURLIETH AVE**

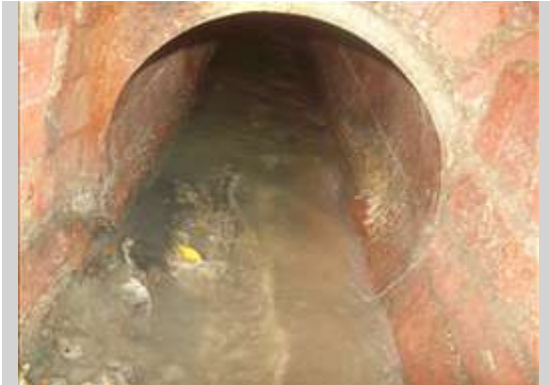
12 O'Clock Outflow

18 in. Circular Gravity Sewer
Pipe Out @ 12 O'Clock

Pipe Height: **13.2** (in.) Rod and Bar
Pipe Material: **Clay** ☐ Pipe Lined
Invert Depth: **24.10** (ft.) Flow Characteristics: **Fast**
Deposits: ☒ None ☐ Mud ☐ Sludge ☐ Debris ☐ Grease
Silt Depth: (in.) Deposits Extent:
Infiltration: **None** Pipe Seal Cond: **Sound**

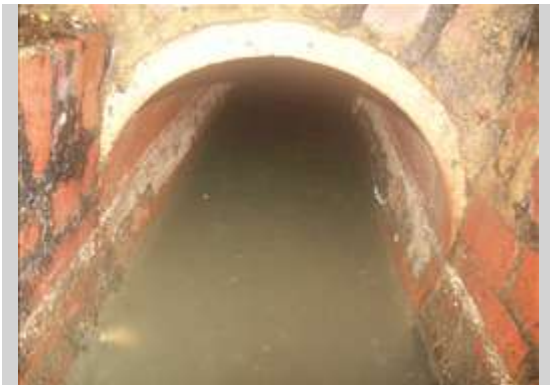
6 O'Clock Inflow

15 in. Circular Gravity Sewer
Pipe In @ 6 O'Clock

Pipe Height: **13.2** (in.) Rod and Bar
Pipe Material: **Clay** ☐ Pipe Lined
Invert Depth: **24.08** (ft.) Flow Characteristics: **Fast**
Deposits: ☒ None ☐ Mud ☐ Sludge ☐ Debris ☐ Grease
Silt Depth: (in.) Deposits Extent:
Infiltration: **None** Pipe Seal Cond: **Sound**

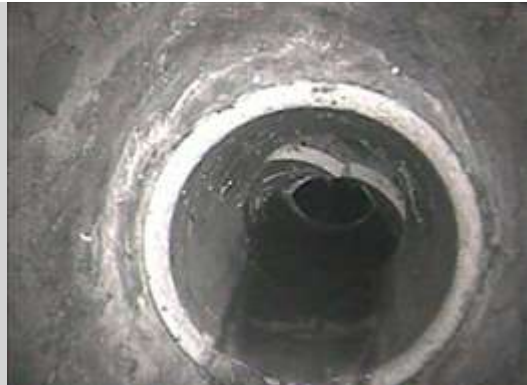
8 O'Clock Inflow

8 in. Circular Gravity Sewer

Pipe In @ 8 O'Clock

Infiltration: **None** Pipe Seal Cond: **Sound**
